INDOOR AIR QUALITY ASSESSMENT

**Charles W. Morey Elementary School
114 Pine Street
Lowell, Massachusetts**

Prepared by:
Massachusetts Department of Public Health
Bureau of Environmental Health Assessment
February, 2001

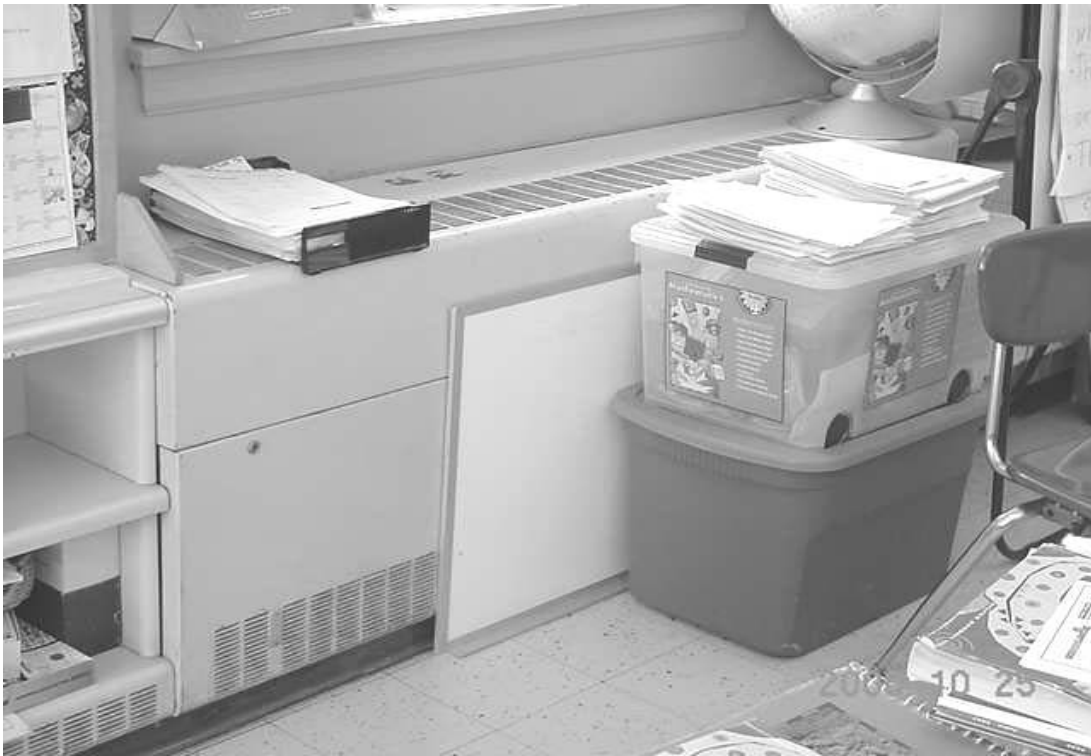
Picture 1

Fresh air in most classrooms is supplied by a unit ventilator (univent) system (see Picture 1). Univents draw air from outdoors through a fresh air intake located on the exterior walls of the building (see Picture 2) and return air through an air intake located at the base of each unit. The mixture of fresh and return air is drawn through a filter and a heating/cooling coil, and is then provided to classrooms from the univent by motorized fans through fresh air diffusers located at the top of the unit ([see Figure 1](#)). Univents were deactivated in a number of classrooms. Without univents operating, the ventilation system does not function as designed, preventing fresh outside air from being distributed to occupied areas. Obstructions to airflow, such as books, papers and posters on top of univents, and bookcases, tables and desks in front of univent returns were also seen in a number of classrooms (see Picture 3). To function as designed, univent air diffusers and returns must remain free of obstructions. It is important that these units be activated and allowed to operate during school hours.

Classroom Univent: Note Return Vent along Front of Unit is Obstructed

- 6) Remove all blockages from univents and exhaust vents to ensure adequate airflow.
- 7) Once both the fresh air supply and the exhaust ventilation are functioning properly, the system should be balanced by an HVAC engineer.

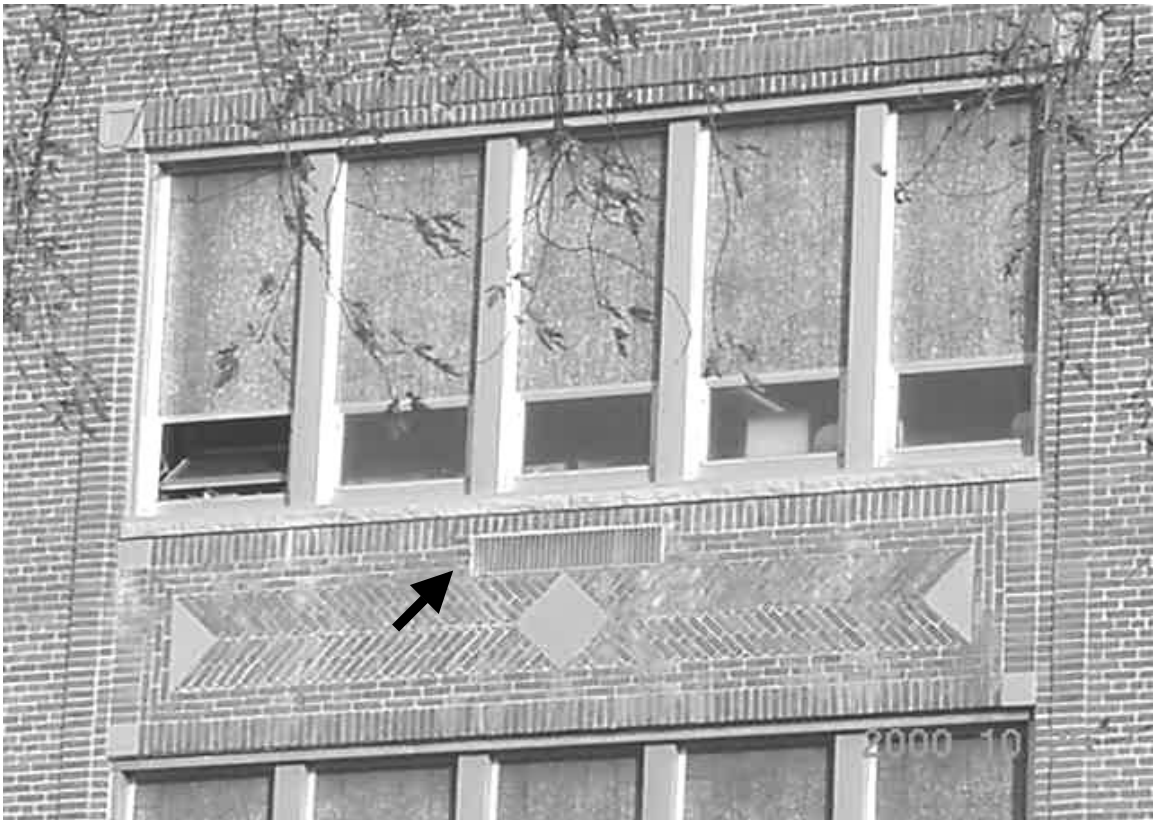
Picture 2

Univent Fresh Air Intake

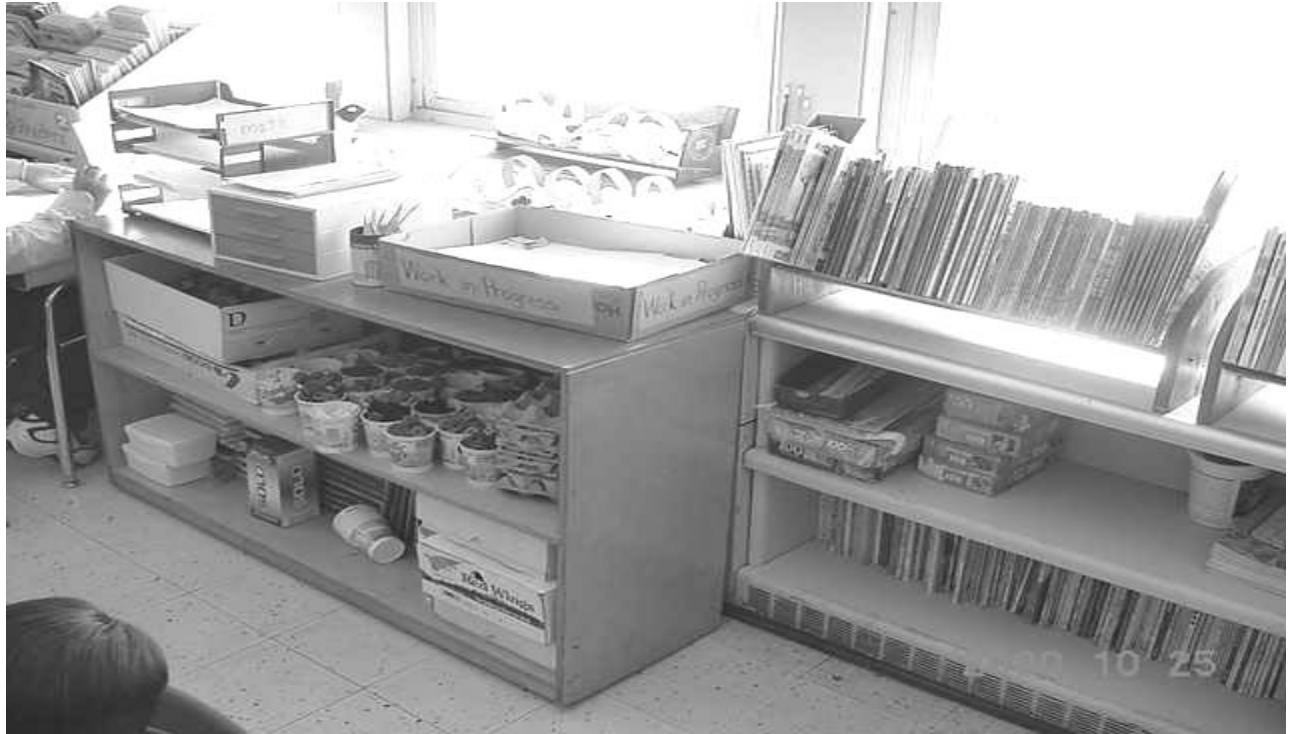
Picture 3

Classroom Univent Obstructed by Bookshelves and other items

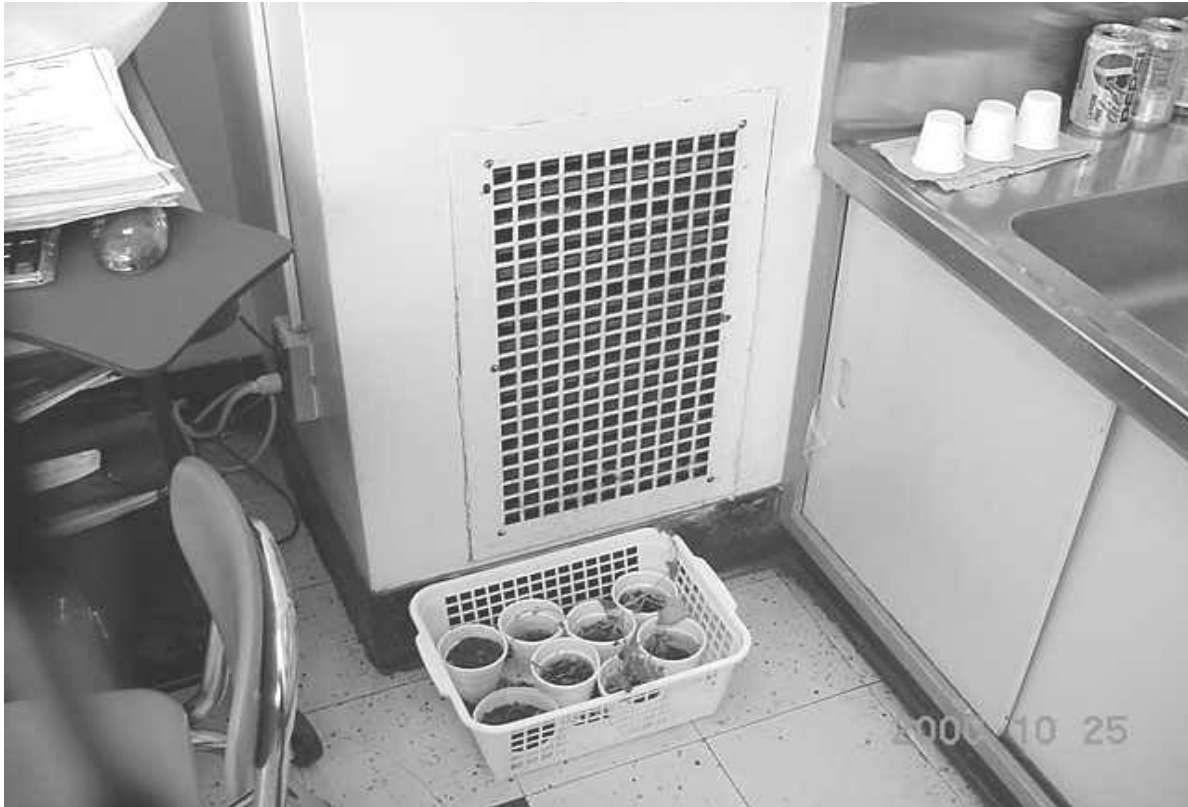
Picture 4

The mechanical exhaust ventilation system for classrooms in the original building consists of ducted, grated wall vents; many of which were obstructed by furniture, storage carts, shelves, and other items (see Pictures 4 & 5). Exhaust vents were not

Classroom Exhaust Vent

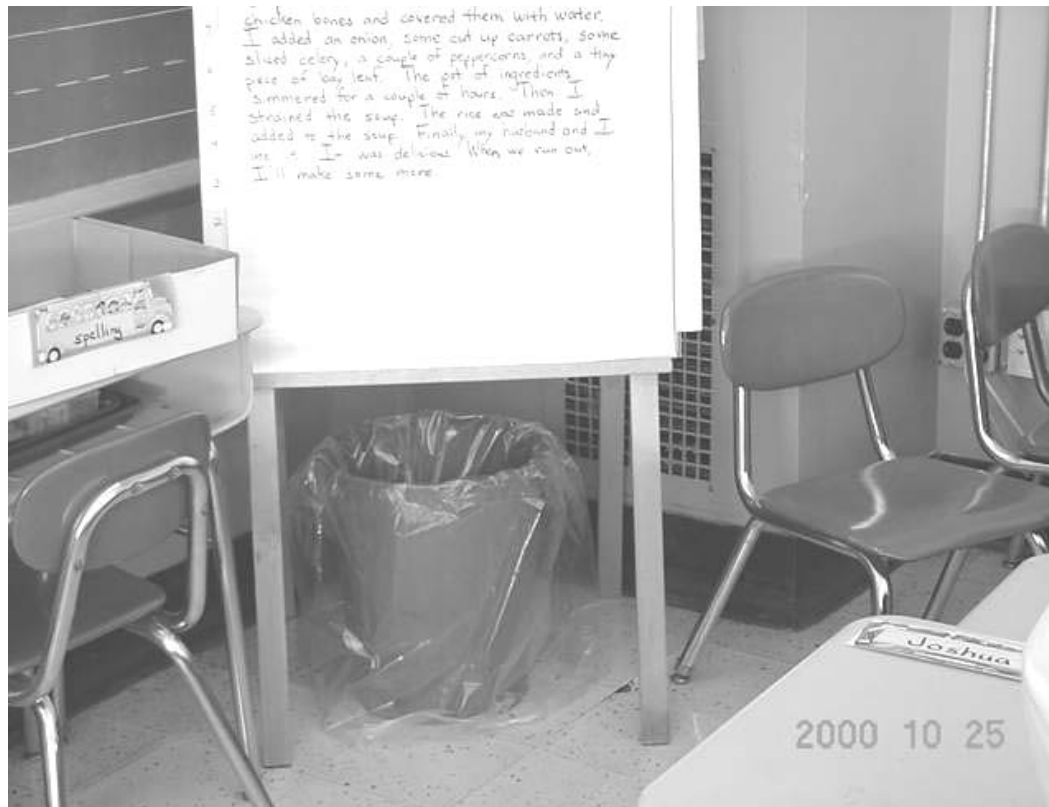
Picture 5

Classroom Exhaust Vent Obstructed by Various Items

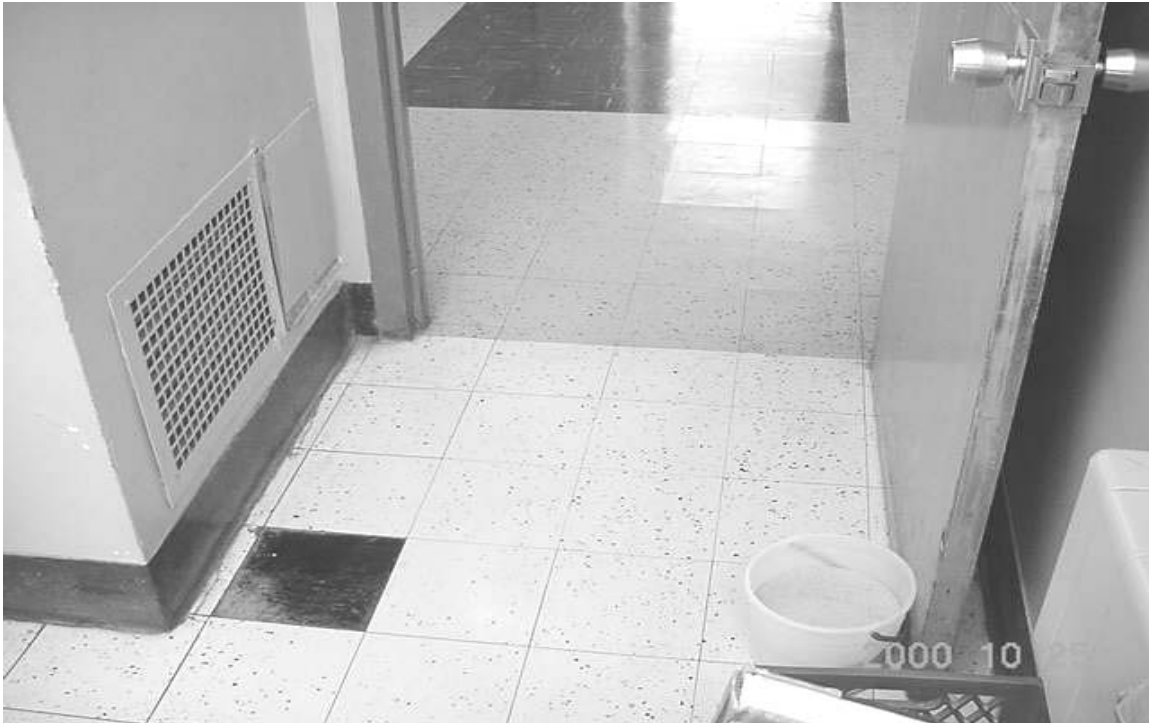
Picture 6

drawing air in a number of classrooms, which can indicate that exhaust ventilation was turned off, or that rooftop motors were not functioning. Hallway doors were found open in a number of classrooms. The location of exhaust vents can limit exhaust efficiency when the classroom door is open (see Picture 6). When a classroom door is open, exhaust vents will tend to draw air from both the hallway and the classroom. The open hallway door reduces the effectiveness of the exhaust vent to remove common environmental pollutants from classrooms. Exhaust ventilation for the 1968 addition is provided by unit exhaust ventilators, some of which were not operating. With decreased function of exhaust vents, normally occurring environmental pollutants can build up and lead to indoor air quality and comfort complaints.

Proximity of Exhaust Vents to Hallway Doors

- 4) Inspect exhaust motors and belts for proper function. Repair and/or replace as necessary.
- 5) Close classroom doors to maximize exhaust ventilation.

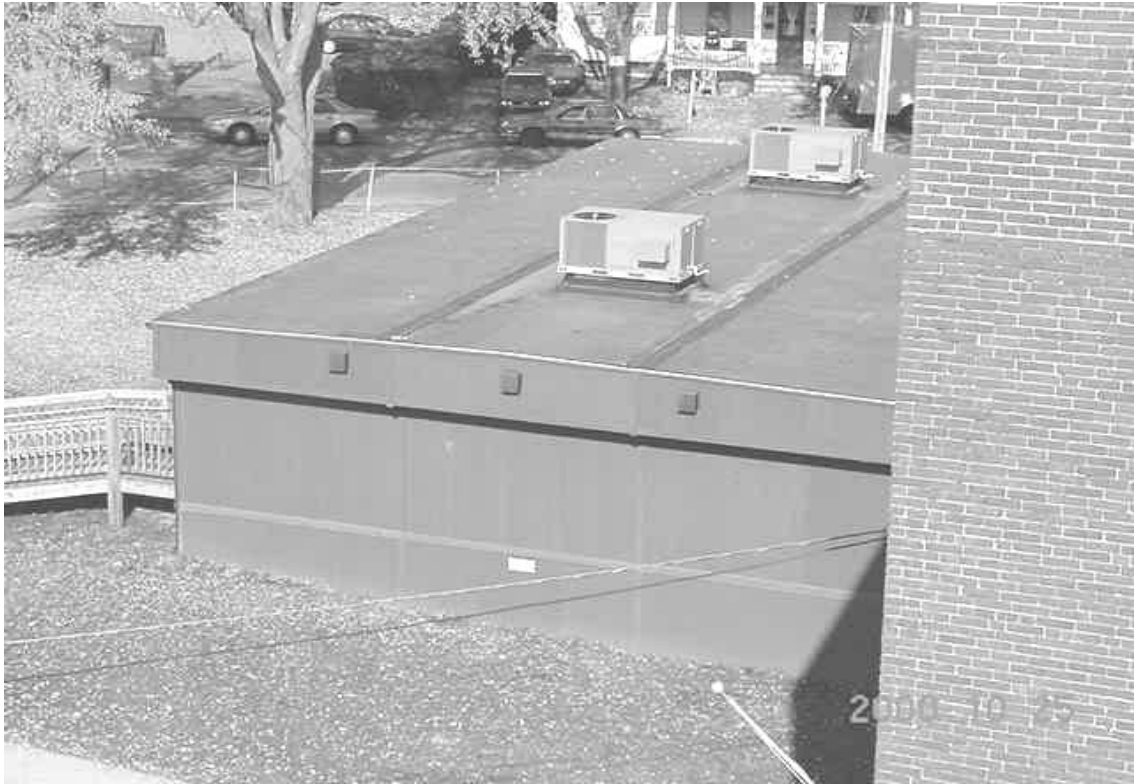
Picture 7

Ventilation for modular classrooms, core rooms and common areas is provided by ducted air handling units (AHUs) located on the roof or in mechanical rooms (see Picture 7). Each modular classroom has its own AHU. Fresh air is distributed via ductwork connected to ceiling-mounted air diffusers. The amount of fresh air drawn into the units is controlled by moveable louvers connected to an activator motor that adjusts to alter fresh air intake to maintain temperature. Return vents draw air back to the units through wall or ceiling-mounted grilles. Thermostats control heating, ventilating and air conditioning (HVAC) systems (see Picture 8). In modular classrooms, thermostats have settings of “on” and “automatic”. Thermostats were set to the “automatic” setting in all of the modular rooms surveyed during the assessment. The automatic setting on the thermostat activates the HVAC system at a preset temperature. Once a preset temperature is measured by the thermostat, the HVAC system is deactivated. Therefore no mechanical ventilation is provided until the thermostat re-activates the system.

Rooftop HVAC Units for Modular Classrooms

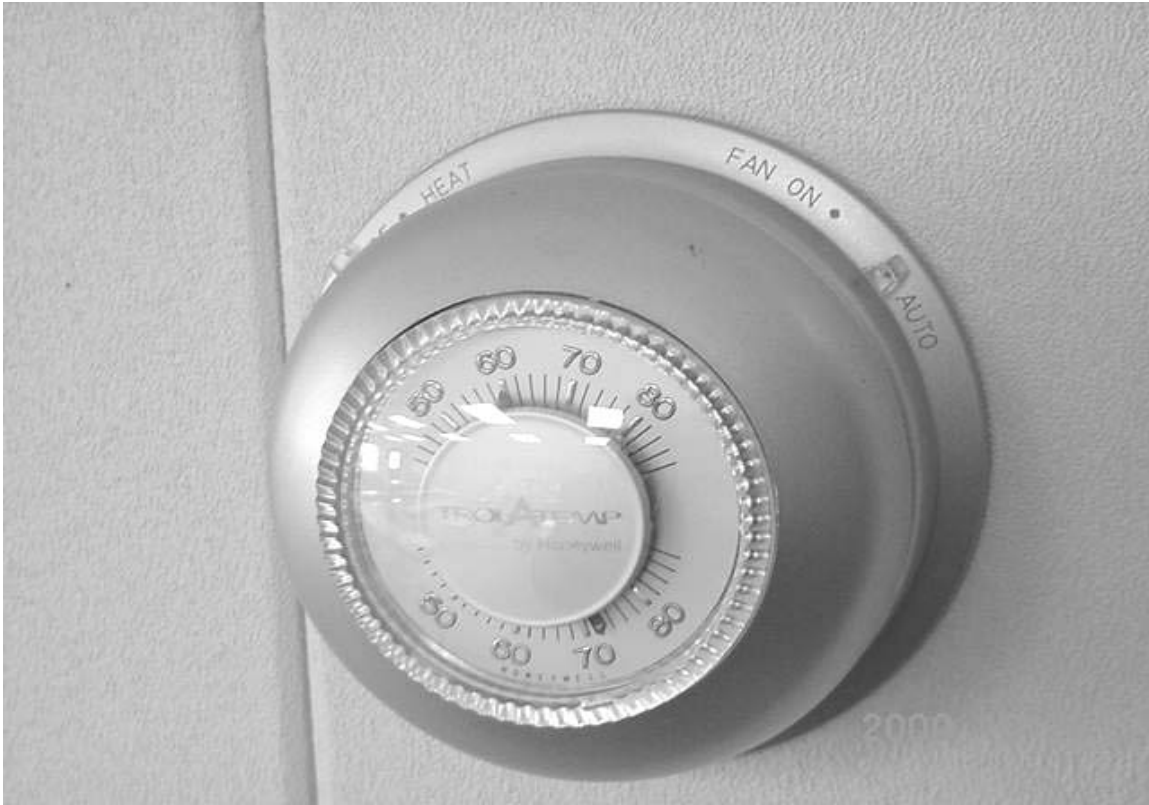
Picture 8

Thermostat Controlling HVAC Unit for Modular Classroom

- 1) To maximize air exchange, the BEHA recommends that both supply and exhaust ventilation operate continuously during periods of school occupancy independent of classroom thermostat control.

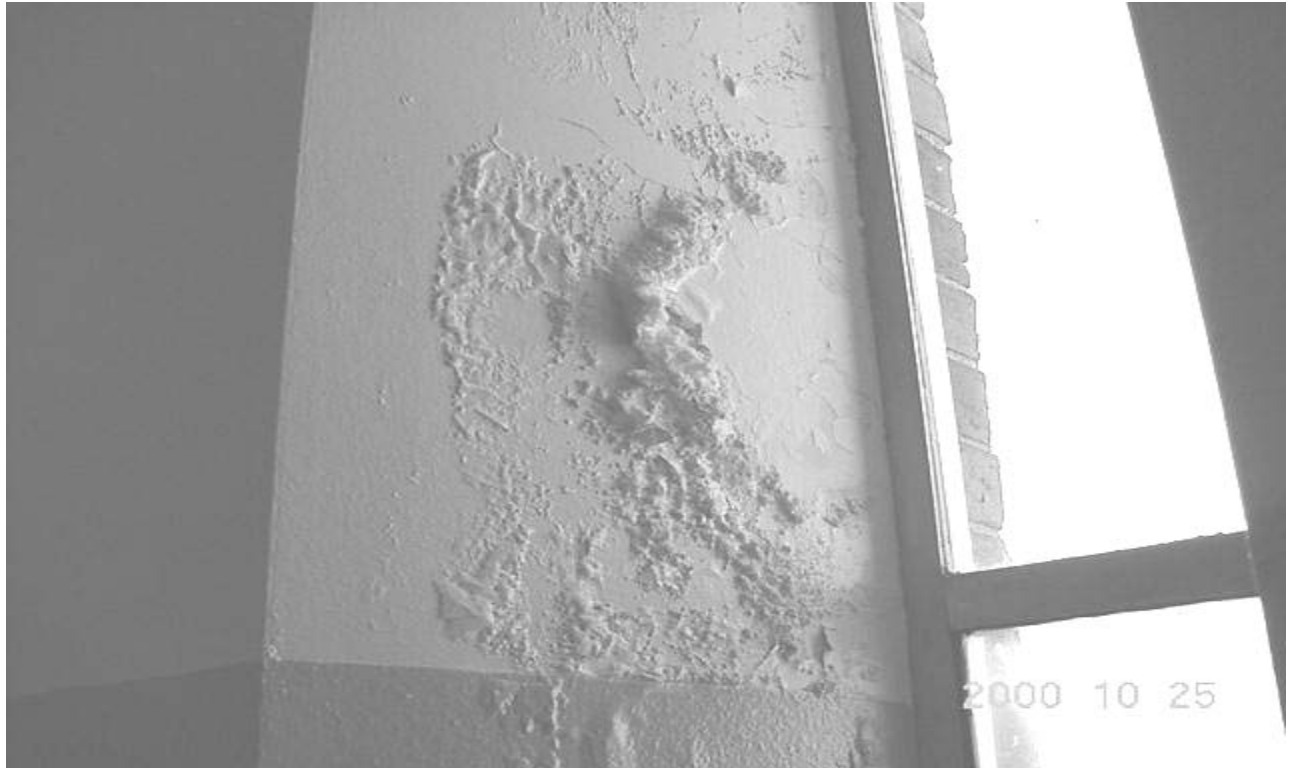
Picture 9

Water damaged ceiling tiles, windowsills and wall plaster were observed in many areas (see Picture 9). Water-damaged ceiling tiles and porous building materials (e.g. wallboard) can provide a source of mold and mildew and should be replaced after a water leak is discovered. Classroom 5 and the hallway ceiling outside of this room contained tiles with possible mold growth (see Picture 10). School maintenance personnel reported that the city public works department had recently repaired a leak in this area, which was confirmed by the presence of a sealant compound noted above the ceiling tiles (see Picture 11). Building occupants reported that the repair was successful.

Water intrusion was evident by the presence of efflorescence (i.e. mineral deposits) and water-damaged plaster around window frames (see Picture 9). Efflorescence is a characteristic sign of water penetration through building materials (e.g.

brick, mortar, plaster) but it is not mold growth. As moisture penetrates and works its way through porous materials, water-soluble compounds dissolve, creating a solution. As this mixture moves to the surface of the material, the water evaporates, leaving behind white, powdery mineral deposits commonly referred to as efflorescence. Water-damaged wall plaster, if wetted repeatedly, can be a medium for mold growth. Repairs of window leaks are necessary to prevent further water penetration. Repeated water damage can result in mold colonization of window frames, curtains and items stored on windowsills.

Water Damaged Wall Plaster (Efflorescence)

- 9) Replace any water-damaged ceiling tiles and building materials. Examine the areas above and around these areas for mold growth. Repair water leaks and disinfect areas of water leakage with an appropriate antimicrobial if necessary.

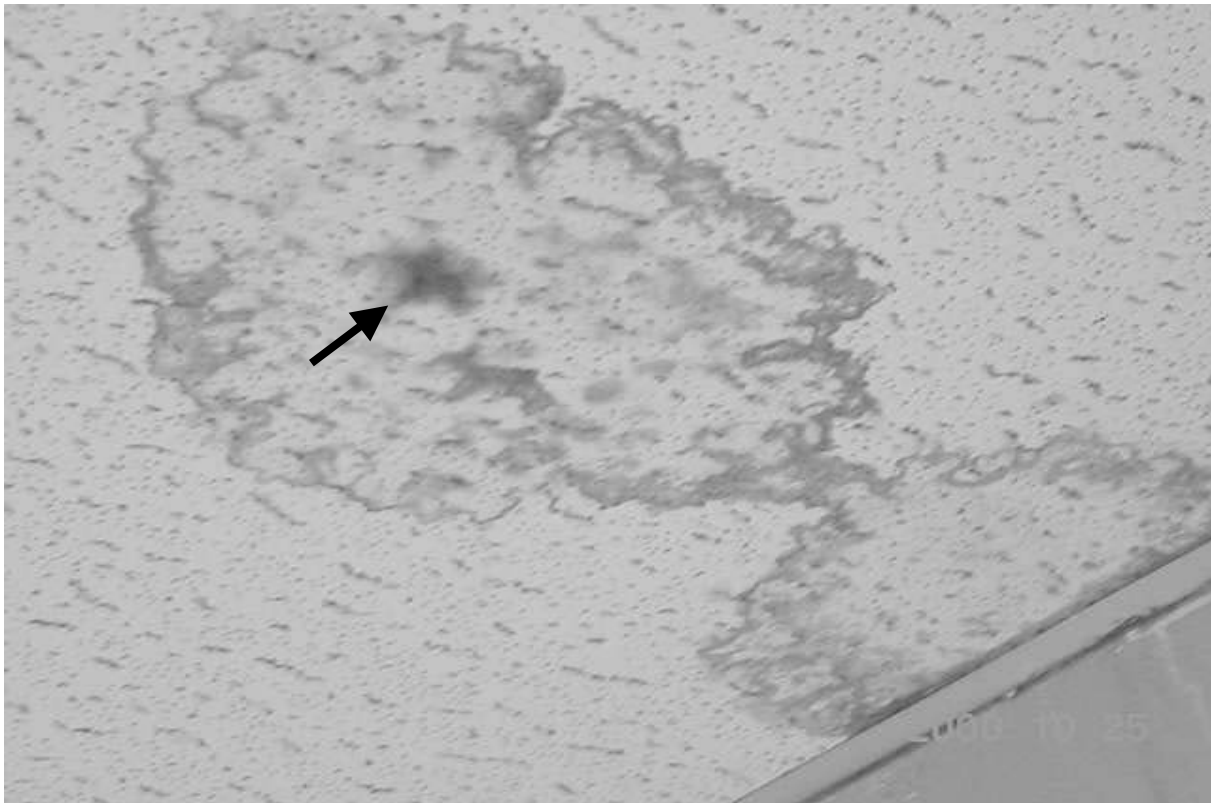
Picture 10

Water Stained Ceiling Tile: Dark Spot Indicates Possible Mold Growth

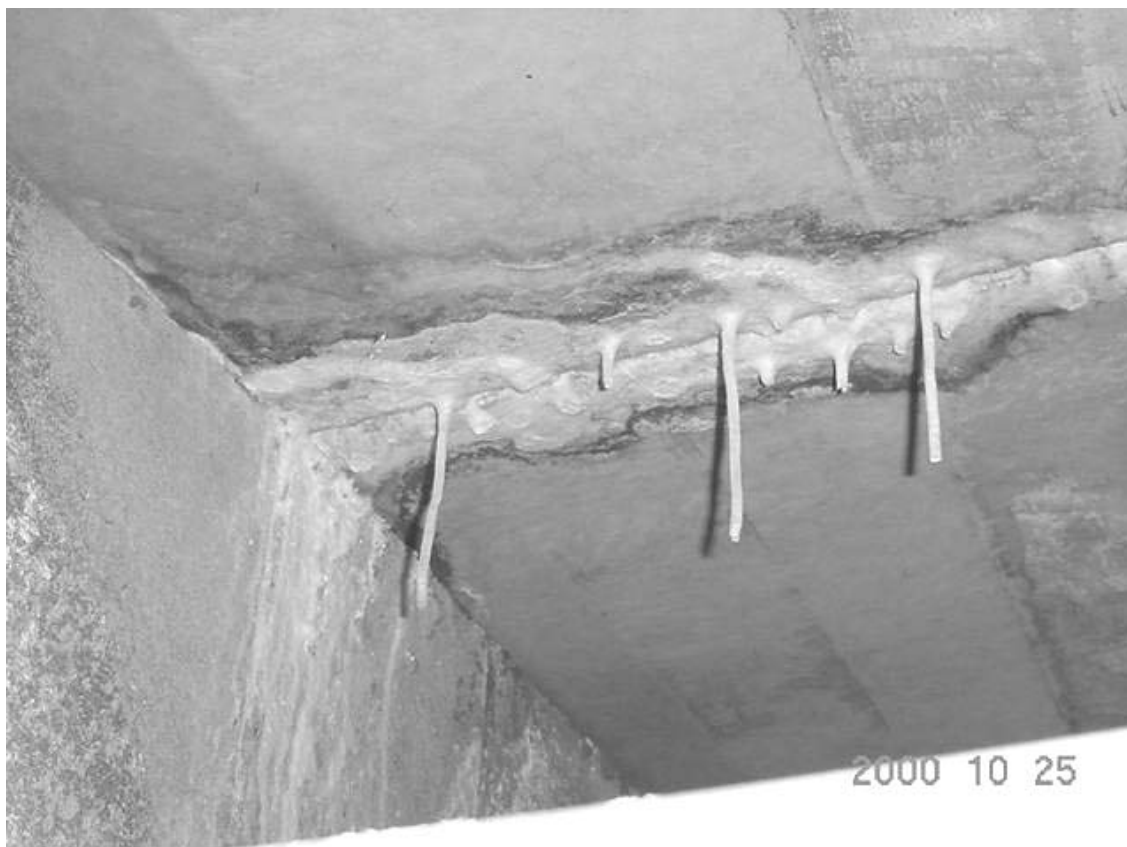
Picture 11

Sealant Compound above Stained Ceiling Tiles in Previous Picture (1968 Addition)

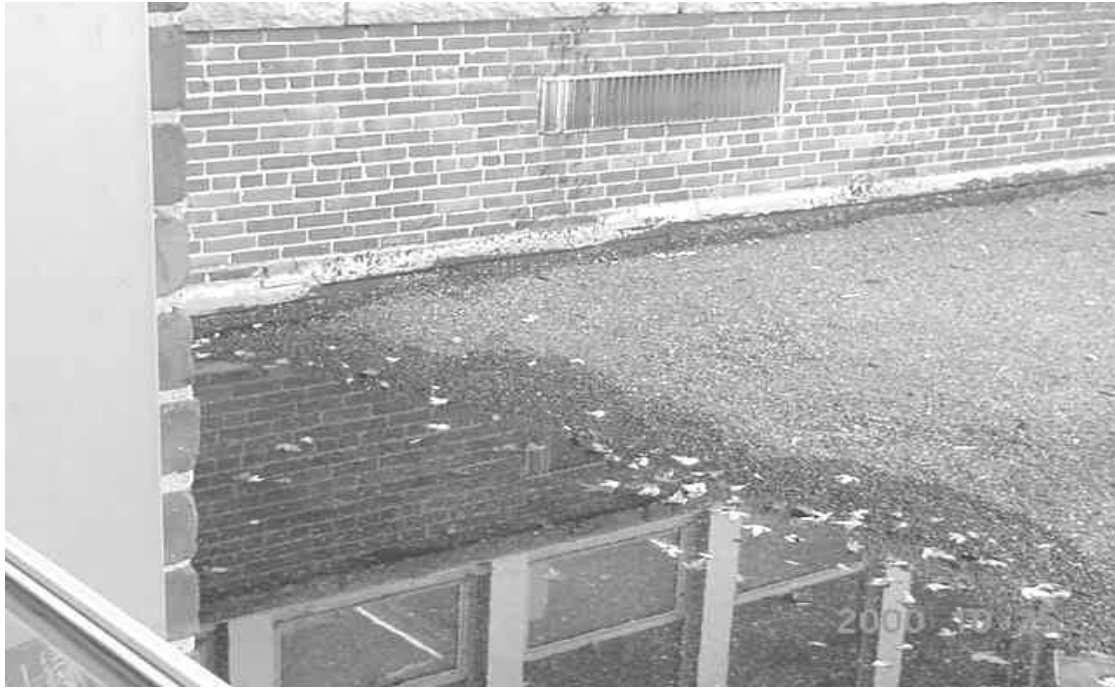
Picture 12

Pooling water was noted on the roof in close proximity to a univent fresh air intake (see Picture 12). The collection of water and the subsequent freezing and thawing during winter months can lead to roof leaks and water penetration into the interior of the building. Pooling water can also become stagnant, which can lead to mold and bacterial growth and subsequently result in unpleasant odors and providing a breeding ground for mosquitoes. The close proximity of water pooling to the fresh air intake creates a potential for the entrainment of moisture into the HVAC system when activated, which can lead to water damage as well as possible mold growth within the unit.

Water Pooling on Roof Near Univent Fresh Air Intake

- 10) Inspect roof for proper drainage. Consider consulting a building engineer about possible options to eliminate water pooling on roof.
- 11) Repair/replace loose, missing or damaged window caulking building-wide to prevent water penetration through window frames.

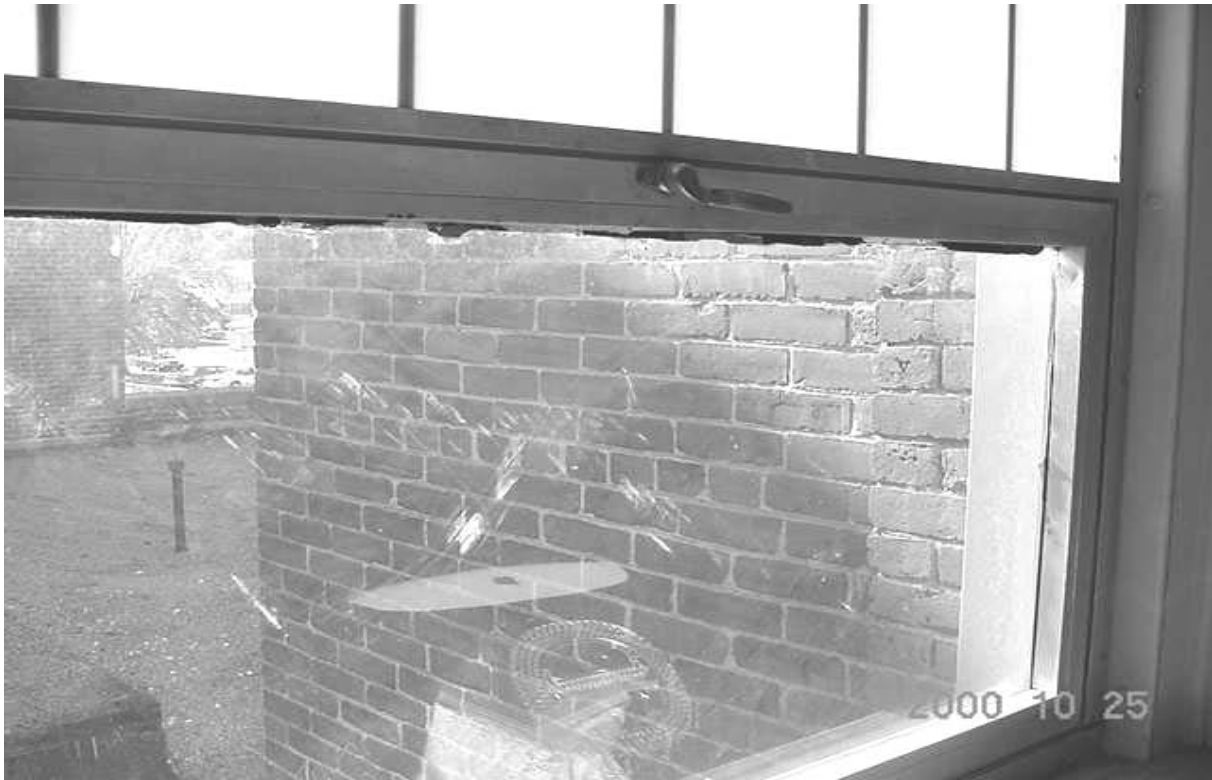
Picture 13

Caulking around windowpanes was crumbling, missing or otherwise damaged in many areas (see Picture 13). Repairs of window leaks are necessary to prevent further water penetration. Repeated water damage can result in mold colonization of window frames, curtains and items stored on or near windowsills.

Crumbling/Damaged Window Caulking

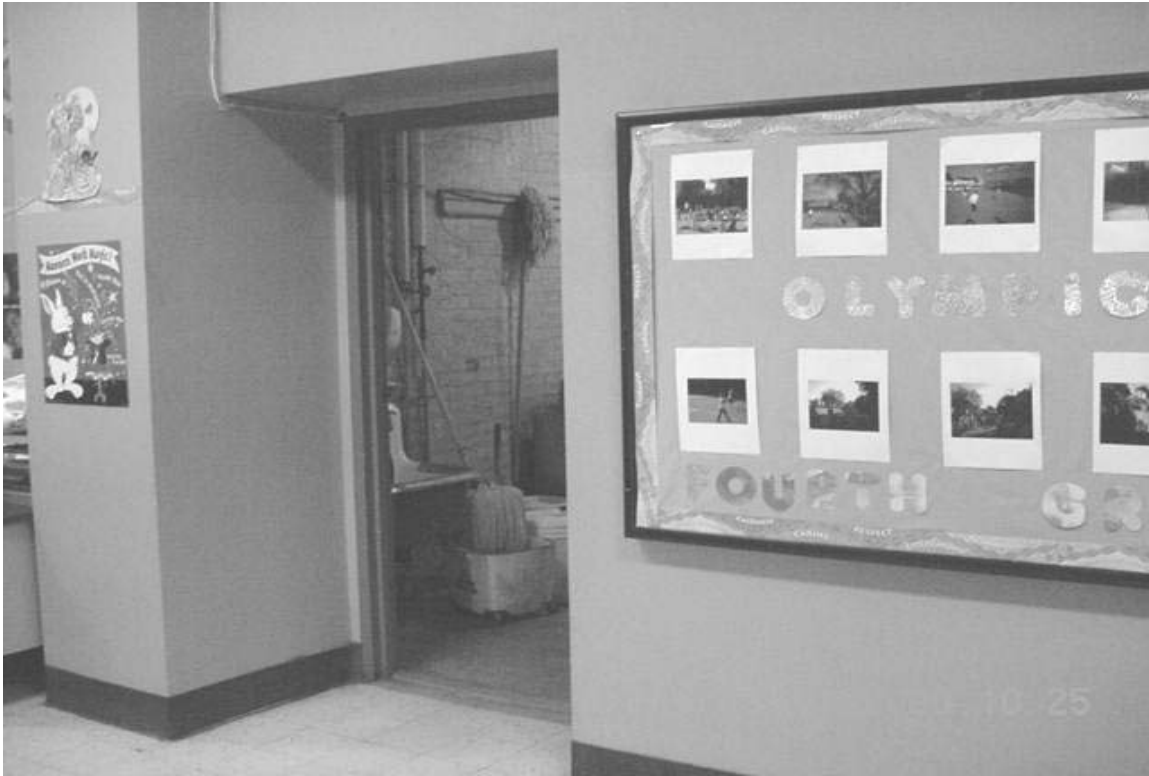
Picture 14

Several conditions that can potentially affect indoor air quality were also identified. The custodial office is located in the boiler room. During the assessment this door was observed open (see Picture 14) and oil fumes and boiler room odors were noted in the main hallway outside this area. The open door to the boiler room can serve as a means of egress for odors, fumes, dusts and vapors from the boiler room into adjacent areas.

Open Boiler Room Door

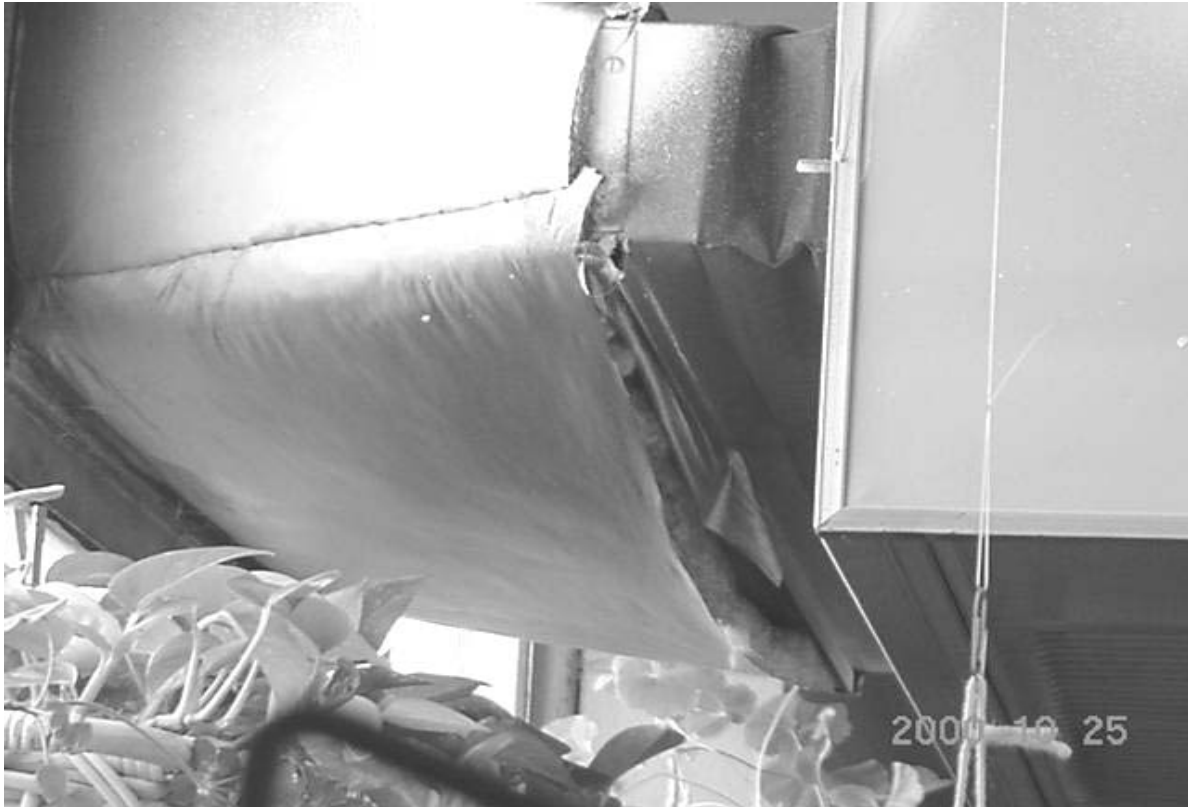
Picture 15

Several areas contained exposed fiberglass insulation (see Tables/Picture 15). Accumulated chalk dust was noted in several classrooms (see Picture 16). Also of note was the amount of materials stored in some areas. In many classrooms and common areas items were seen piled on windowsills, tabletops, counters, bookcases and desks (see Picture 17). The large amount of items stored provides a means for dusts, dirt and other potential respiratory irritants to accumulate. These stored items, (e.g., papers, folders, boxes, etc.) make it difficult for custodial staff to clean. Chalk dust, household dust and fiberglass insulation can become easily aerosolized and serve as a source of eye and

respiratory irritation. In addition, fiberglass insulation material can also serve as a source of skin irritation to sensitive individuals.

Exposed Fiberglass Insulation around Univent Ductwork

- 14) Encapsulate exposed pipe insulation to avoid the aerosolization of fiberglass materials.
- 15) Seal drains in restroom or pour water down regularly to prevent sewer gas back up.

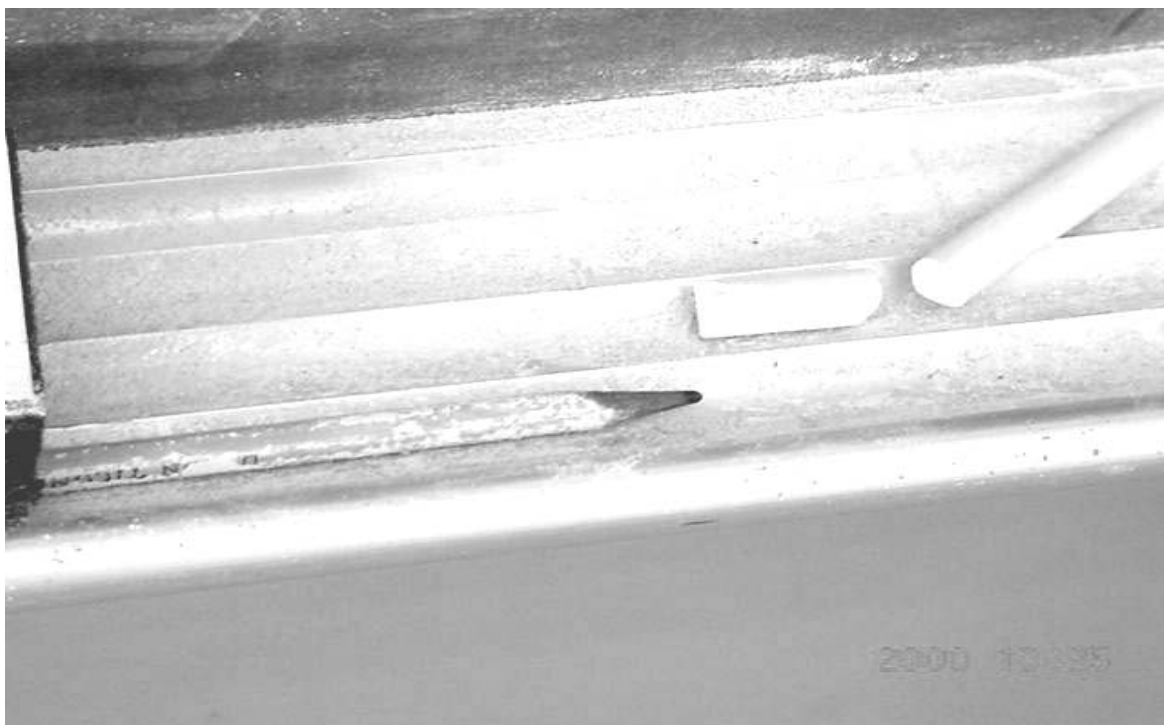
Picture 16

Accumulated Chalk Dust

- 12) Store cleaning products and chemicals properly and keep out of reach of students.
- 13) Clean chalkboards and trays regularly to prevent the build-up of excessive chalk dust.

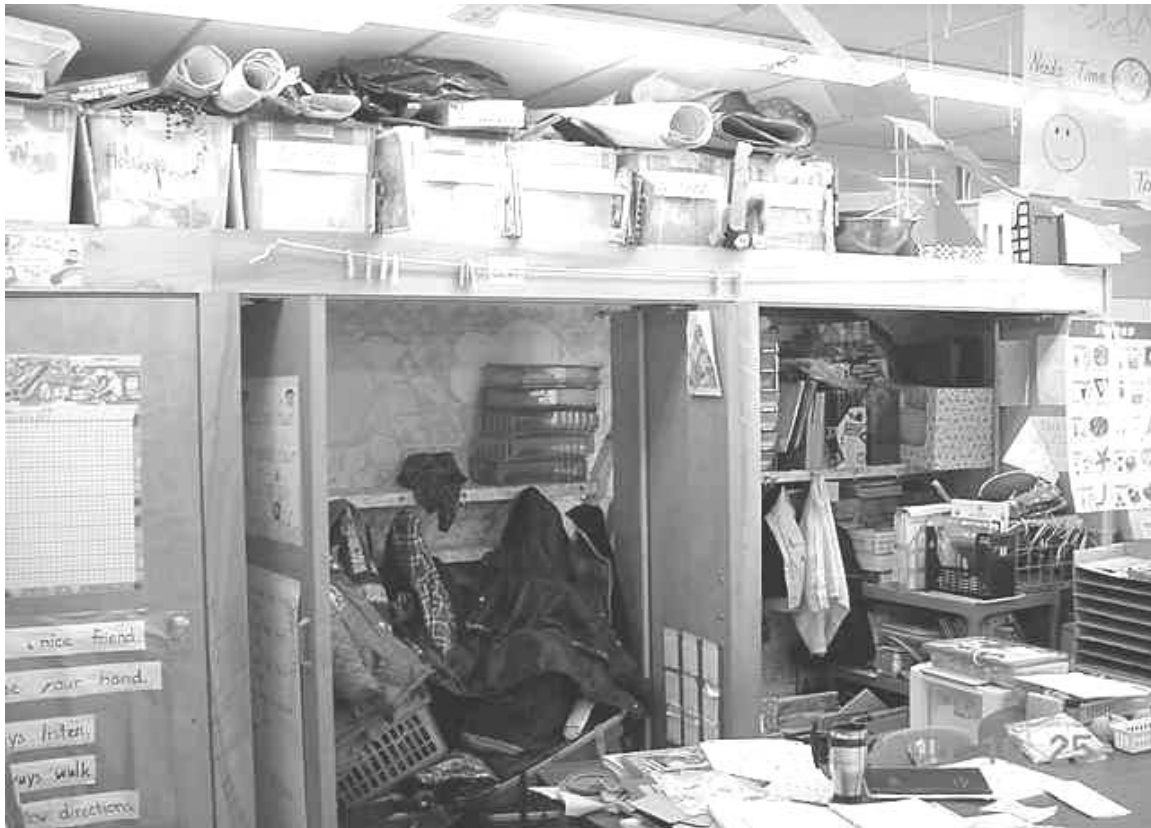
Picture 17

Accumulated Items in Classroom

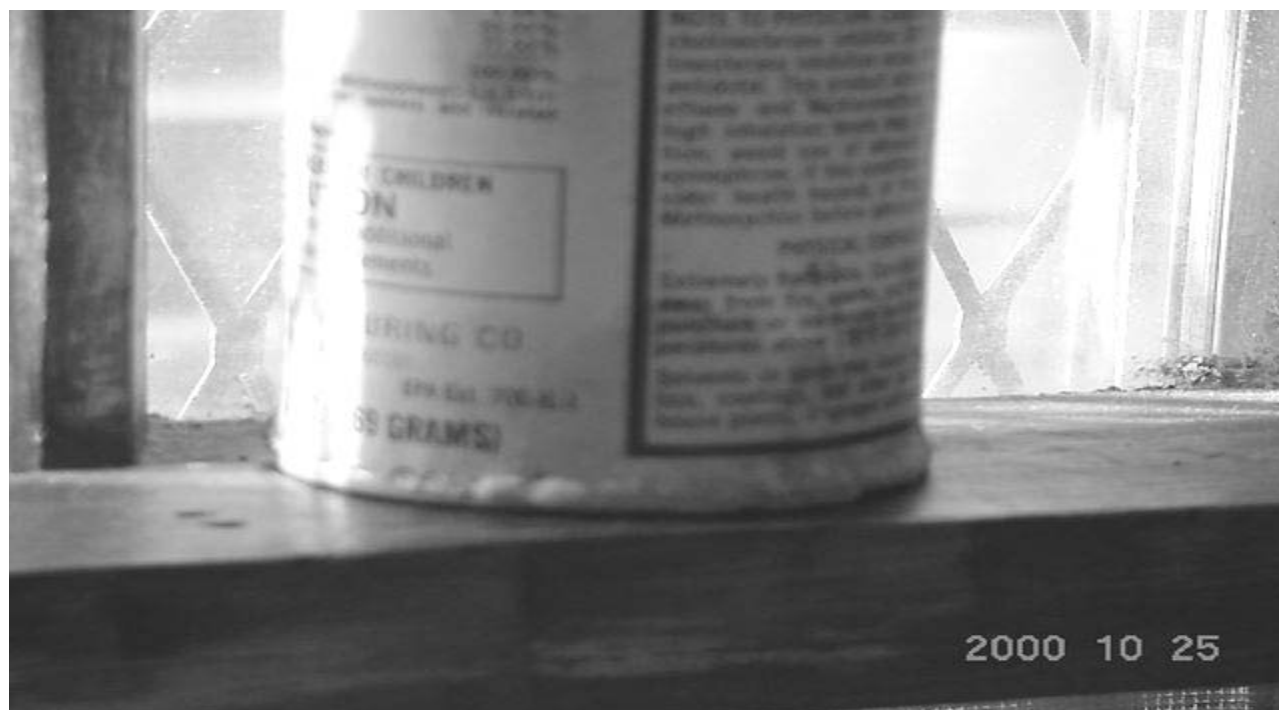
Picture 18

Cleaning products were found in a number of classrooms. A spray can of insecticide was noted in the library (see Picture 18). Cleaning products and insecticides contain chemicals that can be irritating to the eyes, nose and throat and should be kept out of reach of students. In addition, applicators of pesticides should be in full compliance with federal and state rules and regulations that govern pesticide use including posting and notification requirements (333 CMR 13.10). Under no circumstances should this material be applied by untrained personnel. This product should not be applied prior to or during school hours. If application must be done during the school week, this material should be applied shortly after the school day ends, in order to give the applied areas ample time to dry. Under current Massachusetts law that will go into effect November 1, 2001, the principles of integrated pest management (IPM) must be used to remove pests in state buildings (Mass Act, 2000). A copy of the IPM guide is attached as [Appendix A](#).

Spray Can of Insecticide: Note Bubbling at the Bottom of Spray Can

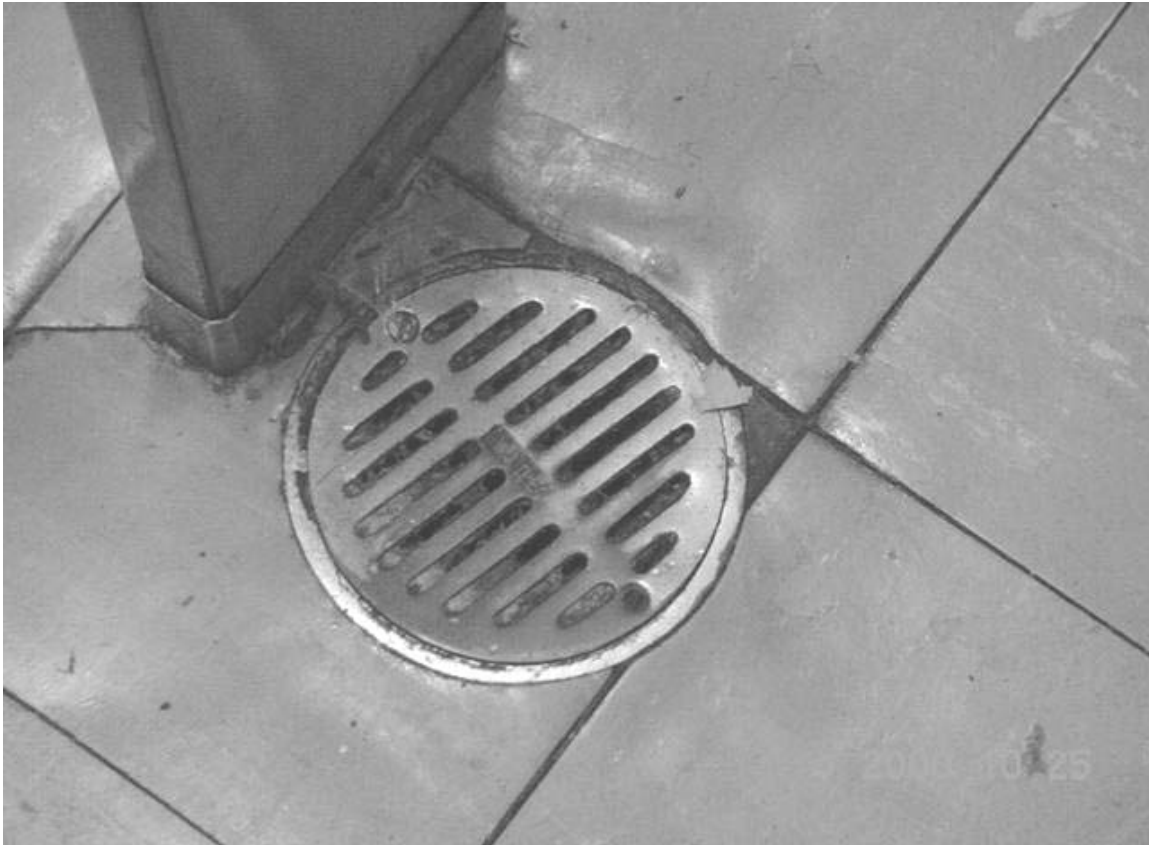
Picture 19

A restroom exists off the main hallway across from the main office, which is also used for storage. This restroom is equipped with floor drains (see Picture 19) used for drainage. Drains are designed with traps in order to prevent sewer odors/gases from penetrating into occupied spaces from the sewer system. When water enters a drain, the trap fills and forms a watertight seal. Without periodic input of water (e.g. every other

day), traps can dry and compromise the integrity of the watertight seal. If traps dry out, sewer odors/gases can travel up the drain into occupied areas. The passive door vent for the boys' restroom was sealed with plywood (see Picture 20). Restroom doors are normally equipped with passive door vents, which allow airflow into restrooms to aid in the removal of odors and water vapor.

Floor Drain in Boy's Restroom, Across from the Main Office

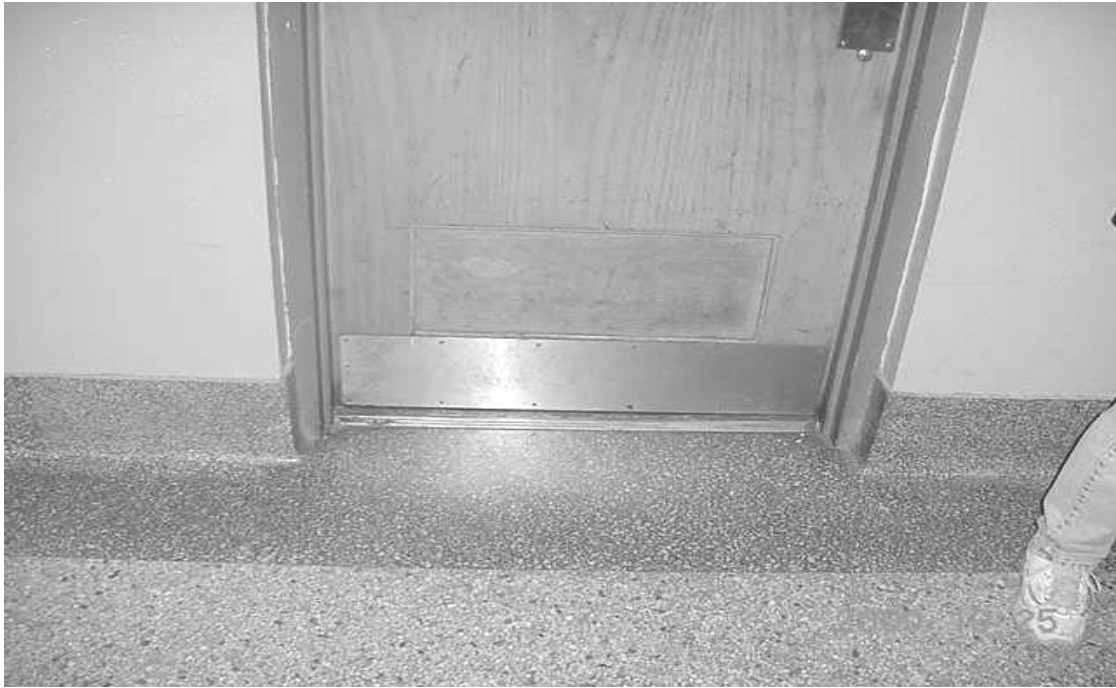
Picture 20

Passive Bathroom Vent Sealed with Plywood

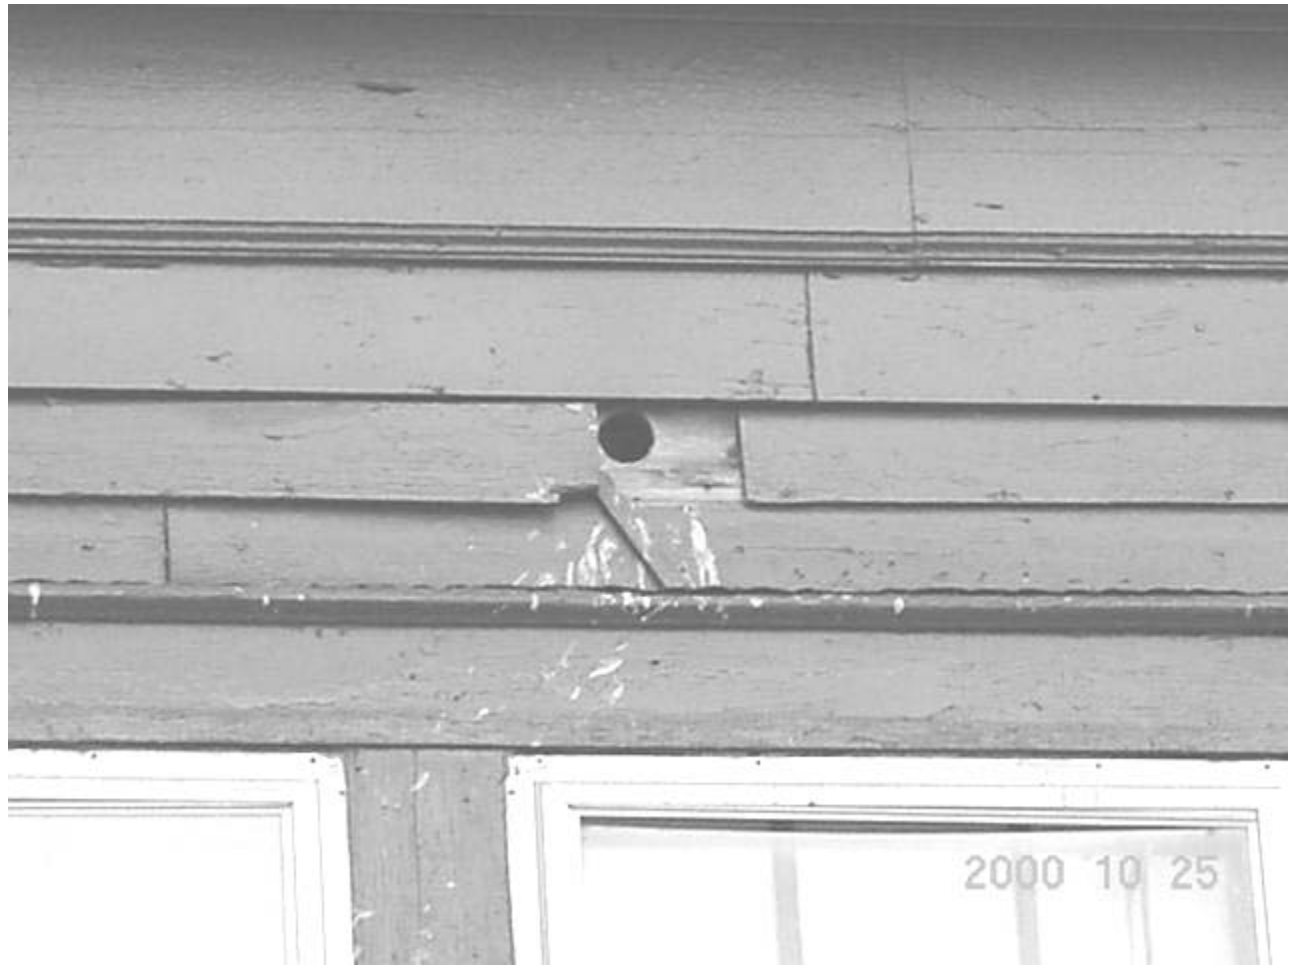
Picture 21

Evidence of bird roosting was noted in a hole in the exterior wall of the annex building (see Picture 21). Accumulations of bird wastes were noted in and around the opening on the exterior of the building. No evidence of bird infestation was observed in the occupied portion of the annex building, however, the building does contain an attic, which BEHA staff were unable to observe. Birds can be a source of disease, and bird wastes and feathers can contain mold and mildew, which can be irritating to the respiratory system.

Hole in Side of Annex Building Occupied by Birds: Note Bird Waste on Side of Building

- iii) Reduction of harborages (plants/cardboard boxes) where pests may reside.
- 17) Determine extent of bird roosting in annex building depicted in Picture 14. If extensive, the area should be professionally cleaned of all bird wastes and

disinfected. Seal breach in the exterior of the building to prevent reoccupation by birds.
